US Army Corps
of Engineers
Waterways Experiment
Station

Miscellaneous Paper CERC-93-5
July 1993

Monitoring of East Breakwater Rehabilitation at Cleveland Harbor, Ohio

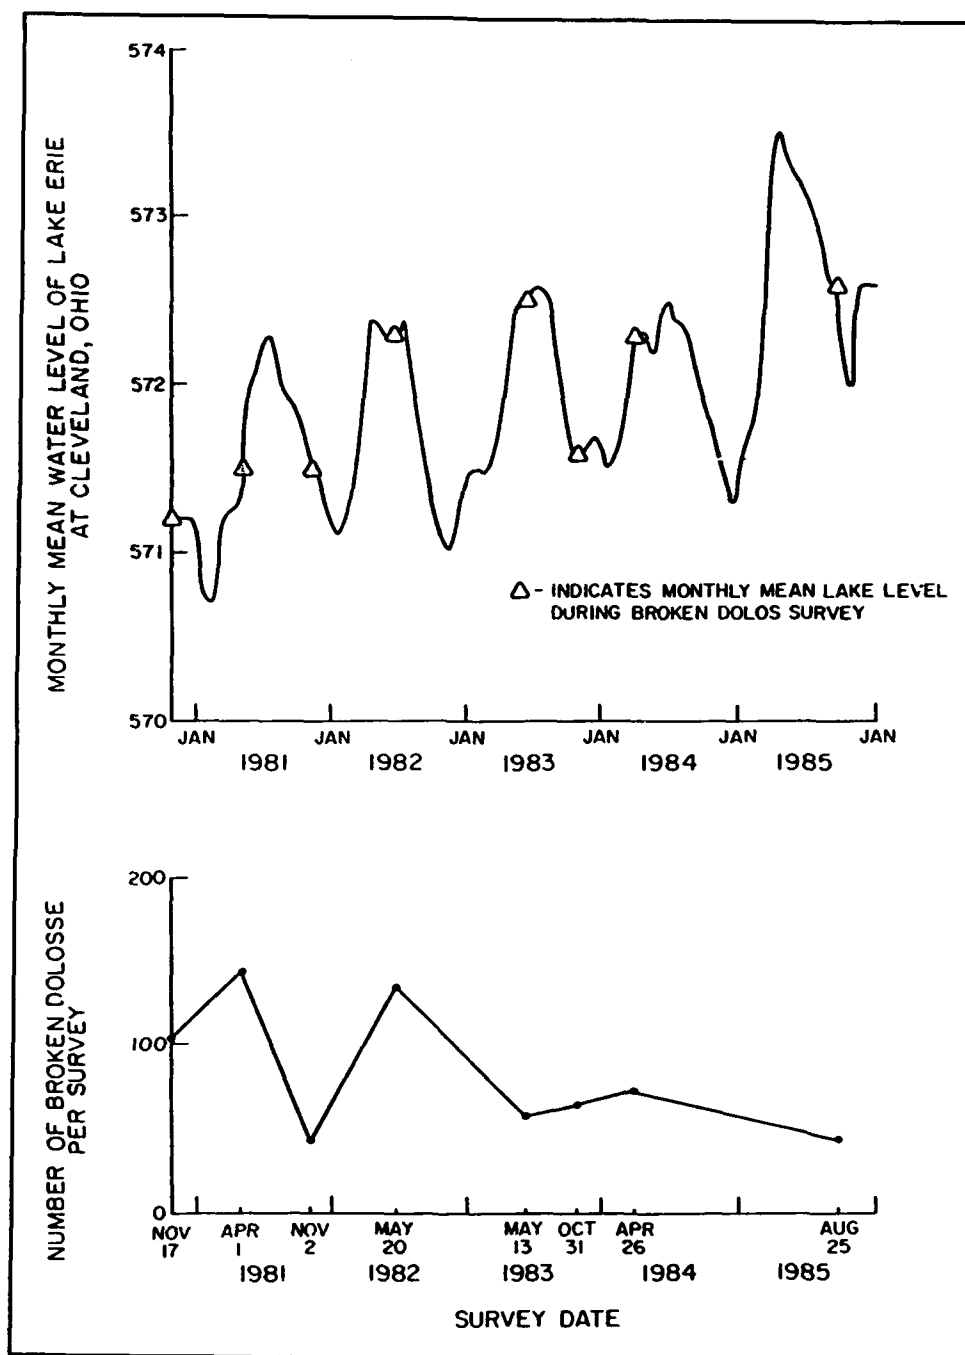
Figure 26. Monthly mean lake level versus number of newly broken dolosse per survey

Lake levels were monitored continuously during the monitoring period. Still-water levels generally ranged between +2 and +5 ft lwd during the period 1982-1985; however, the effect of short-term lake level change was demonstrated by the April 1982 storm during which the daily mean was +4.48 lwd, but the instantaneous level was +6.14 lwd. Lake levels occurring during periods when wave conditions were being monitored ranged from about +2.5 to +4 ft lwd. Monthly mean lake levels over the monitoring period are presented in Figure 26 as well as the number of broken dolosse per survey. It appears that there is no correlation between lake levels and the amount of armor unit breakage, though the water level may affect the location of breakage on the breakwater. Increase in water level during storm conditions may result in damage higher up on the structure and explain dolos breakage near the structure's crest. Also, lake levels at the time of broken dolos surveys will affect the number of armor units visible to the survey team.
